Reference: EPA Contract No. 68-W4-0006; Work Assignment No. R05052  
Environmental Priorities Initiative (EPI) Assessments; Certified Technology,  
Inc., Rockford, Illinois, EPA ID No. ILR000016980; PA/VSI Report and  
NCAPS Scoring Report; Task 04 Deliverable

**PRELIMINARY ASSESSMENT/VISUAL SITE INSPECTION  
FOR  
CERTIFIED TECHNOLOGY, INC.  
EPA ID No. ILR000016980  
915 22nd STREET  
ROCKFORD, ILLINOIS**

**APPENDIX A**  
**Visual Site Inspection Photograph Log**

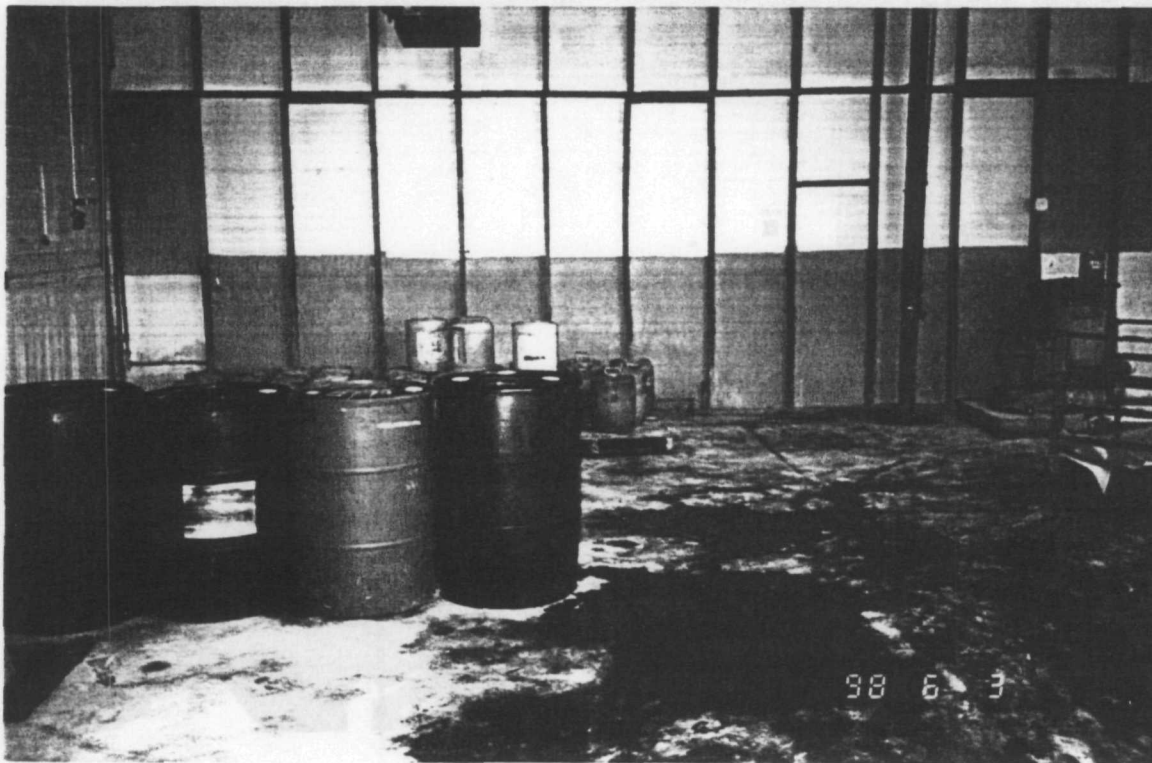
Report Photograph No.: 1

Description: View of the Former Hazardous Waste Storage Area (SWMU 1). The 55-gallon drums are used for accumulating hazardous wastes while the smaller containers in the background are used for product storage.

**Physical Description:** This unit consists of an approximately 15 foot by 25 foot area of concrete floor which is free of cracks or other indications of integrity problems. During the VSI, some water was observed in the vicinity of the unit, however, no evidence of release was observed from the four 55-gallon plastic drums stored at the unit. Prior to May 1997, this area was used for the storage of various containerized hazardous wastes. During a March 8, 1996 RCRA CEI, IEPA determined that the facility had been generating RCRA hazardous waste for 10 years without shipping any of it off-site. The unit was RCRA closed and a no further action letter was sent to the facility on May 7, 1997. The area is currently used for the accumulation of D002, D007, D008, and D010 hazardous wastes and may also be used for the accumulation of non-hazardous wastes. Following the accumulation of a full drum, the waste is transferred to the Hazardous/Non-Hazardous Waste Storage Area (SWMU 2) prior to off-site disposal/treatment. No secondary containment devices were identified in association with this unit.

**Conclusions:** Based on a concrete inspection during closure, IEPA's determination the unit had been closed in accordance with the approved closure plan, and observations made during the VSI, it does not appear that this unit has released to the environment. Therefore, no further action is recommended for this unit.

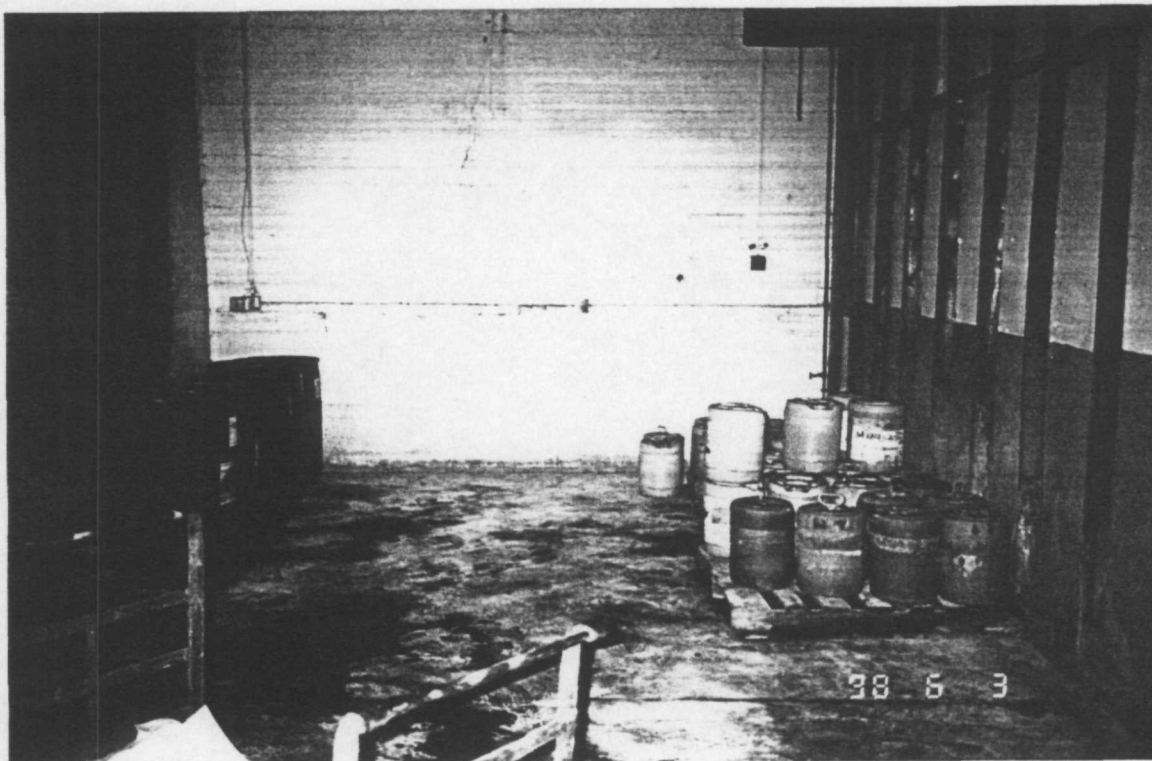
Report Photograph No.: 2  
Logbook Photograph No.: 1-2  
Date: 6/3/98

Description: Another view of the Former Hazardous Waste Storage Area (SWMU 1). Product is stored in the 5-gallon plastic containers seen to the right. The 55-gallon drums are used for the accumulation of hazardous wastes.

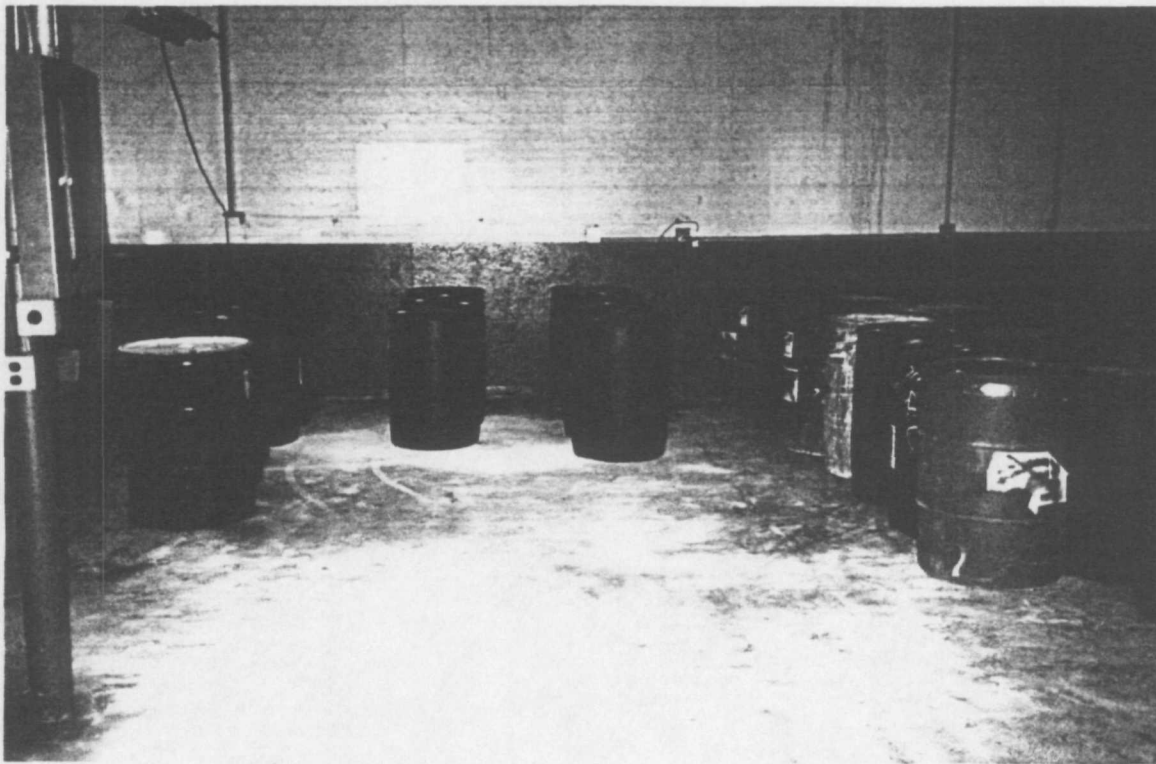
Report Photograph No.: 3  
Logbook Photograph No.: 1-3  
Date: 6/3/98

Description: View of the Hazardous/Non-Hazardous Waste Storage Area (SWMU 2). At the time of the VSI, hazardous waste was stored in the 13 drums located in the left half of the photo.

**Physical Description:** This unit is a less than 90-day storage area which is situated on the crack free concrete floor of the facility building and occupies a total area of approximately 40 feet by 20 feet. The hazardous waste portion occupies an area measuring approximately 15 feet by 20 feet. The remaining area is used for the storage of non-hazardous wastes. At the time of the VSI, 13, 55-gallon drums of hazardous waste and approximately 100 drums of non-hazardous waste were present. Small quantities of product were also observed in this area, stored in 5-gallon and smaller containers. No secondary containment devices were identified in association with this unit at the time of the VSI.

**Conclusions:** No further action is recommended since the unit is located indoors on sealed concrete and there is no evidence of releases.

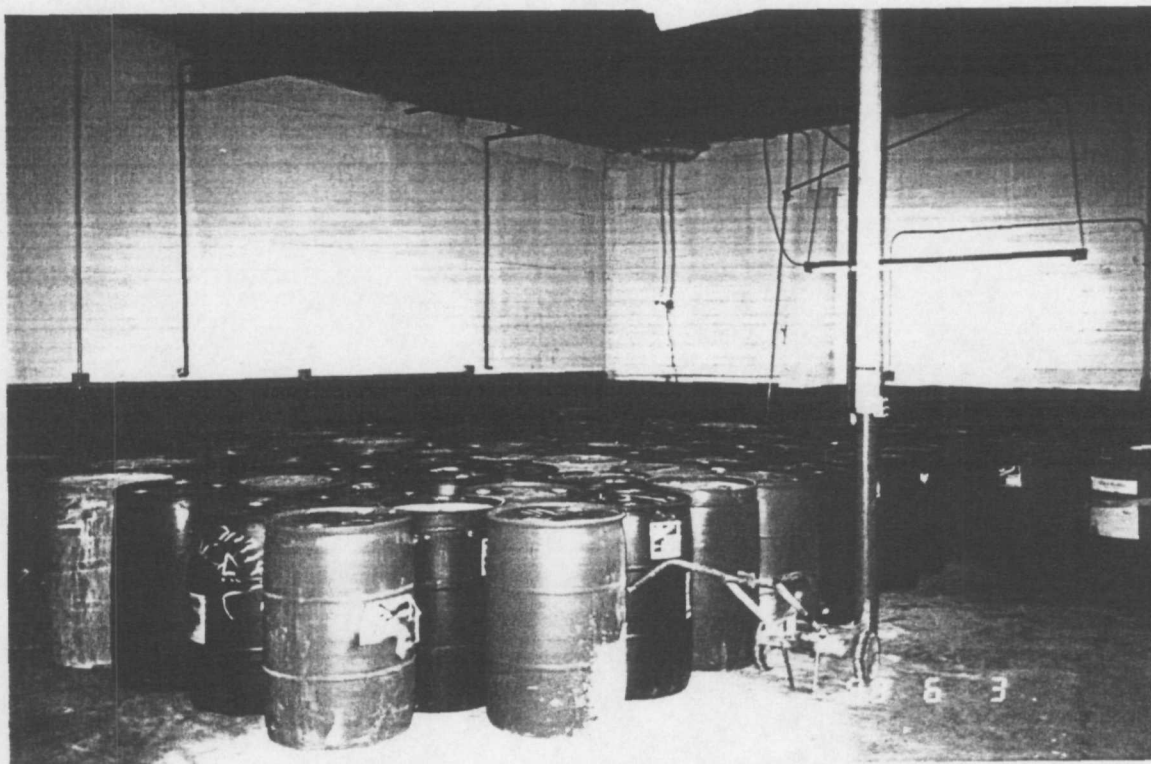
Report Photograph No.: 4  
Logbook Photograph No.: 1-4  
Date: 6/3/98

Description: Another view of the Hazardous/Non-Hazardous Waste Storage Area (SWMU 2), focusing on the non-hazardous waste portion. Approximately 100 drums of non-hazardous waste were present in total, approximately 75 drums were nickel wastes and 25 were miscellaneous wastes.

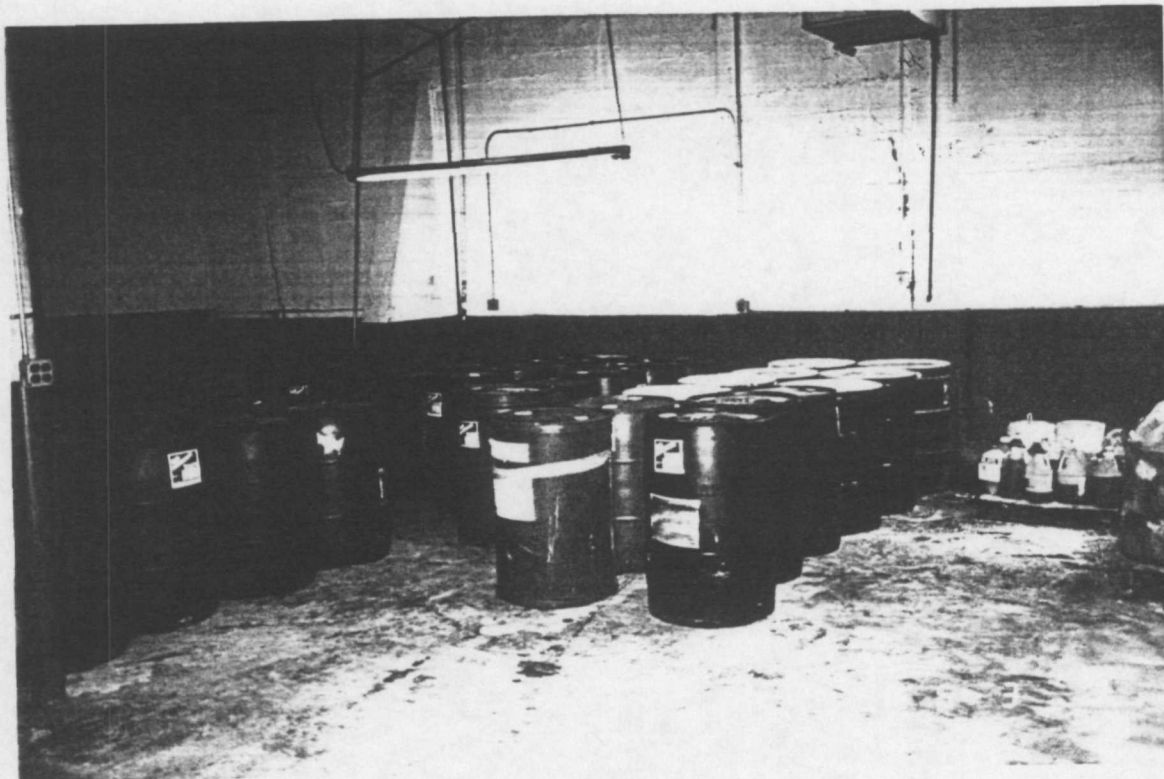
Report Photograph No.: 5  
Logbook Photograph No.: 1-5  
Date: 6/3/98

Description: Another view of the Hazardous/Non-Hazardous Waste Storage Area (SWMU 2). The wastes are primarily non-hazardous floor sweepings to the left and non-hazardous plating sludge to the right. The 1-gallon containers to the right were reportedly product.
